# GENERAL MANAGER REPORT

FEBRUARY 2026

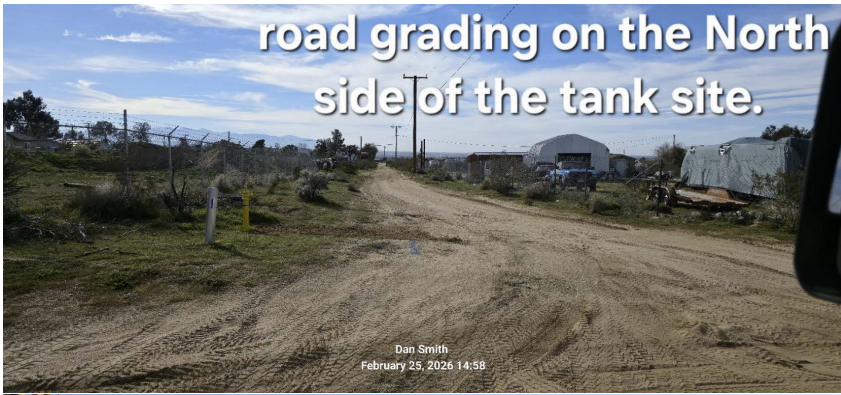
road grading on the North side of the tank site.

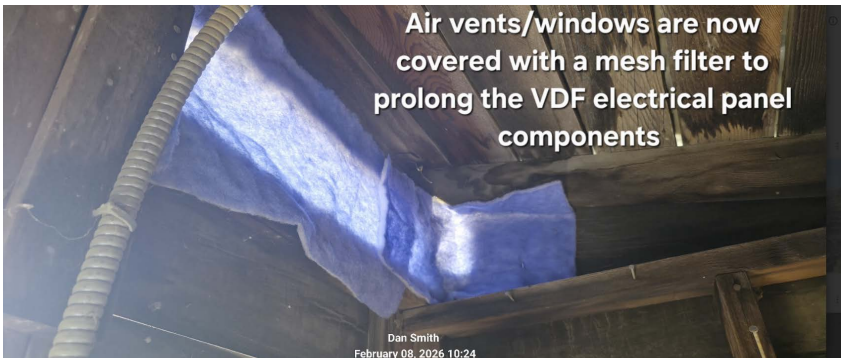
Air vents/windows are now covered with a mesh filter to prolong the VDF electrical panel components

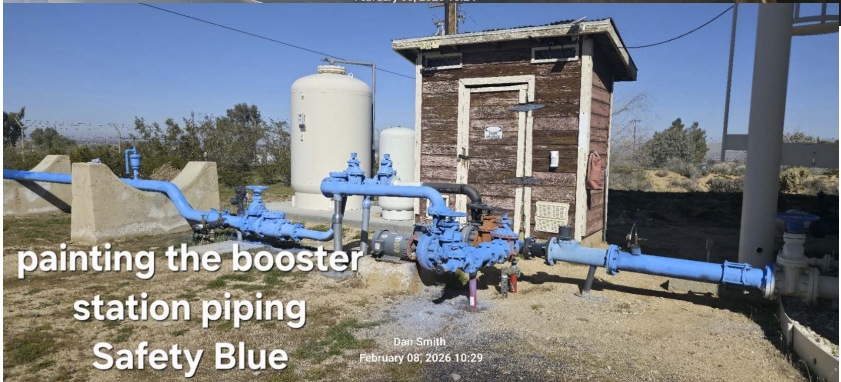
painting the booster station piping Safety Blue

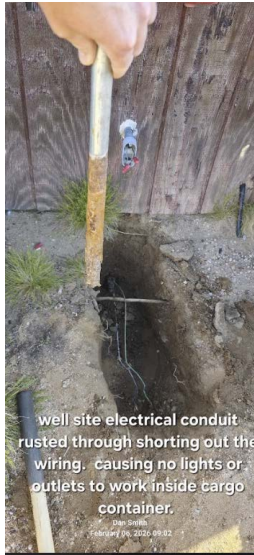
well site electrical conduit rusted through shorting out the wiring, causing no lights or outlets to work inside cargo container.
