# GENERAL MANAGER REPORT

FEBRUARY 2026

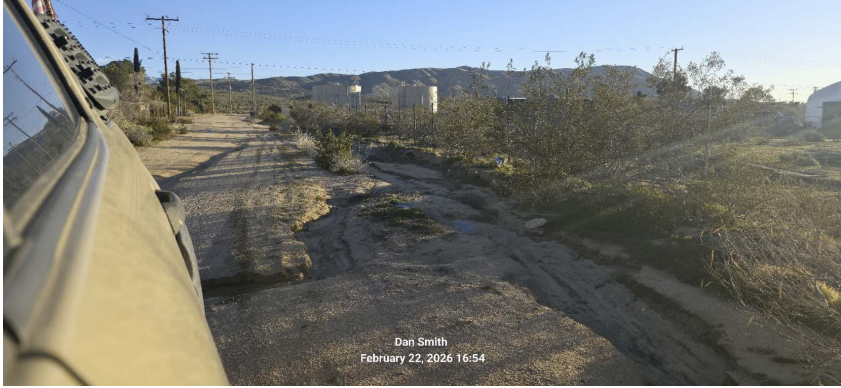
road grading on the North side of the tank site.

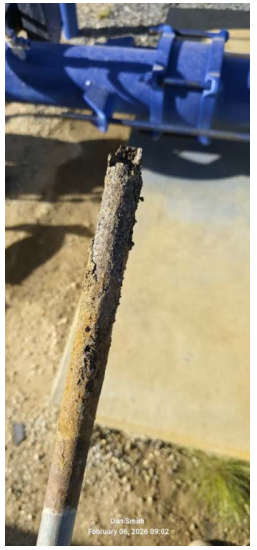
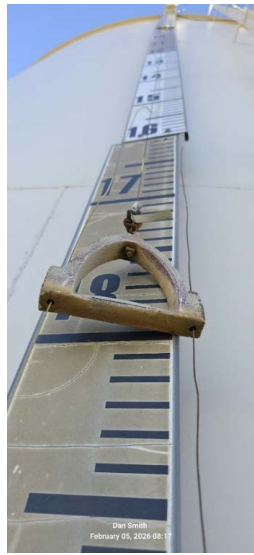
well site electrical conduit rusted through shorting out the wiring, causing no lights or outlets to work inside cargo container.
